Former Plainwell Impoundment Time-Critical Removal Action Weekly Construction Update

Progress Report #18—September 10, 2007

Work Completed: August 30-September 5, 2007

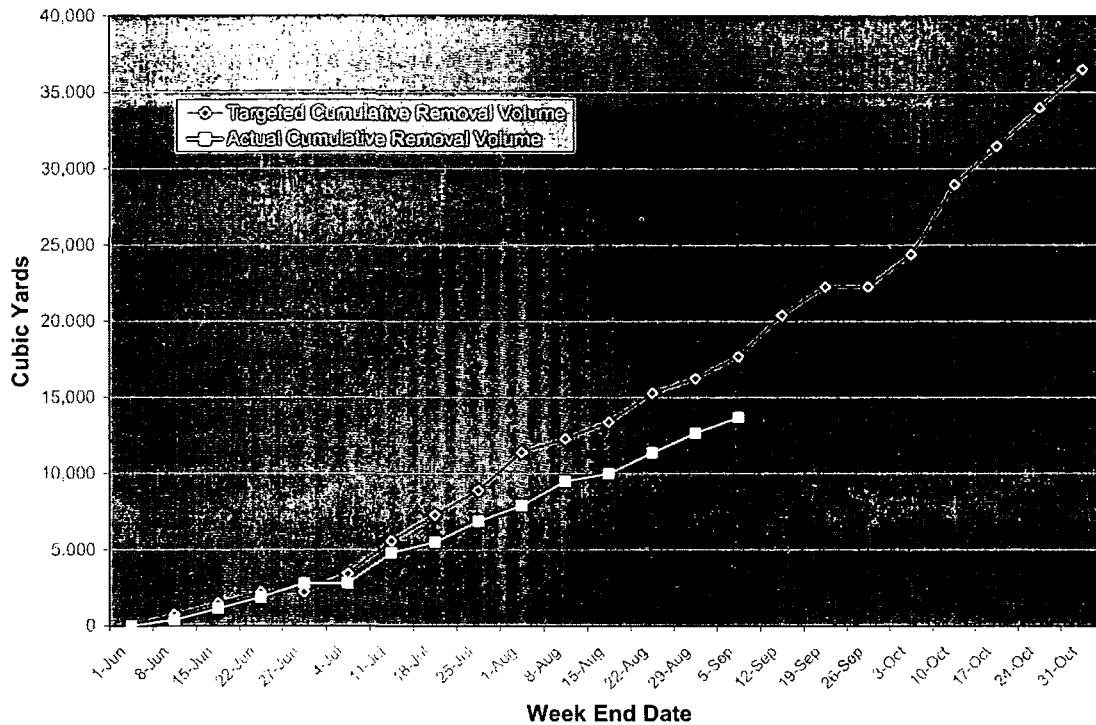
Removal Progress

Targeted volumes are neat and subject to change due to additional excavation done at request of USEPA.

Actual volumes removed are below the targeted volumes potentially due to the conservative estimation methodology used to develop targeted figures and due to the actual topographic conditions encountered at the site, which could result in smaller volumes needing to be removed than originally estimated. The targeted volumes have been increased by 10% to account for additional material that could be removed as a result of over-excavation and additional removal in response to confirmation sampling. Soil/sediment removal activities are on schedule based on the ARCADIS BBLES 4/30/07 Plainwell TCRA Construction Schedule.

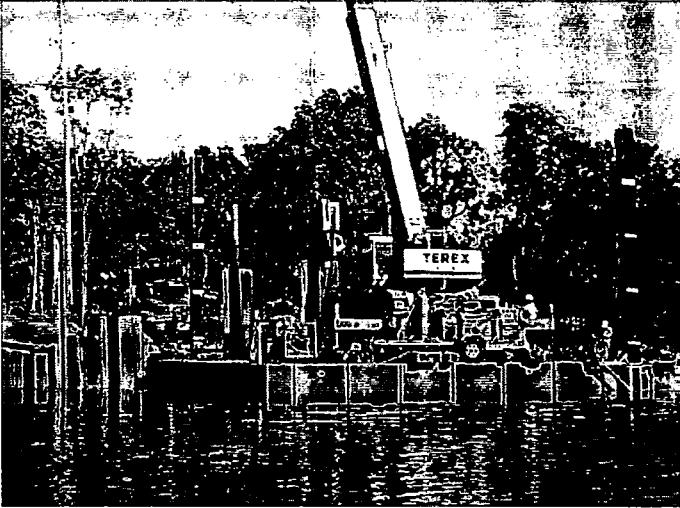
Installing steel sheeting for the Phase I cofferdam.

- An impact hammer and crane will be mobilized to the Site to assist in driving steel sheeting for the Phase I cofferdam to the revised design depth.

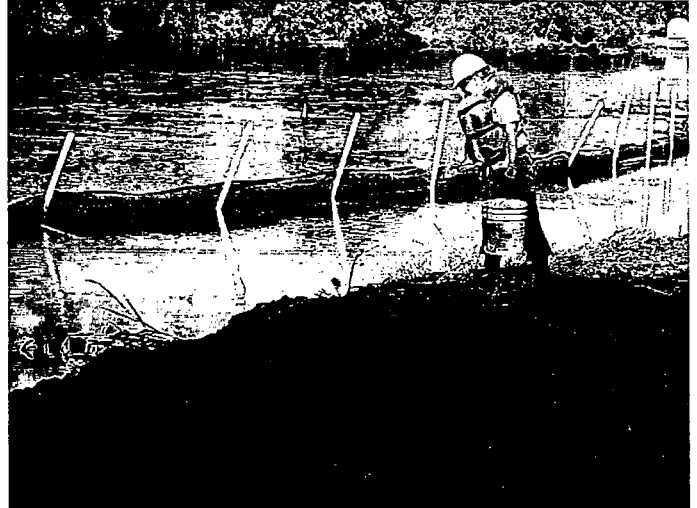
Seeding in Removal Area 1.

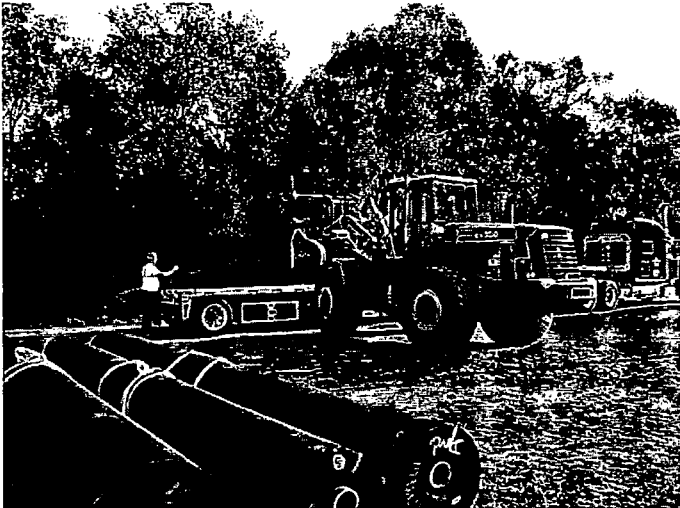
Unloading geosynthetic materials for staging area construction.

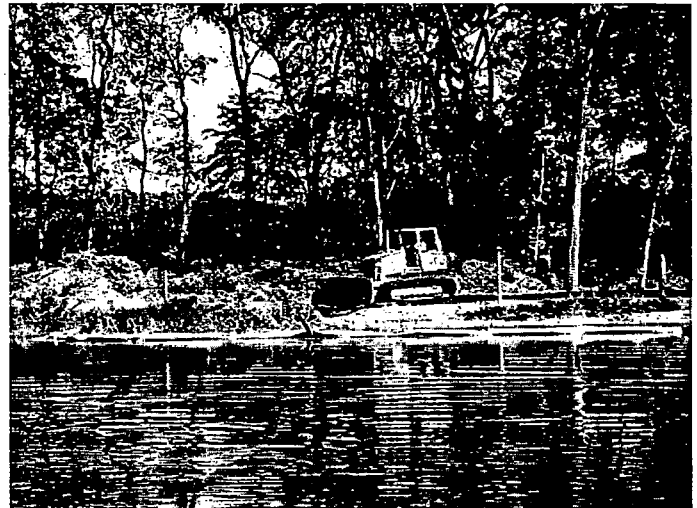
Performing grading as a part of post-excavation activities.
